Inspection Report

Brooks Home Advisor

Property Address:

123 Somewhere Dr.

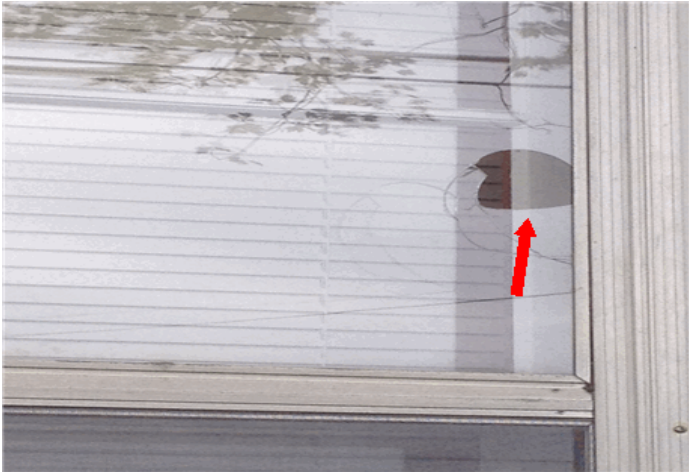
7) Window Conditions

R

Broken glass on front of home. I recommend repair by qualified contractor. See picture

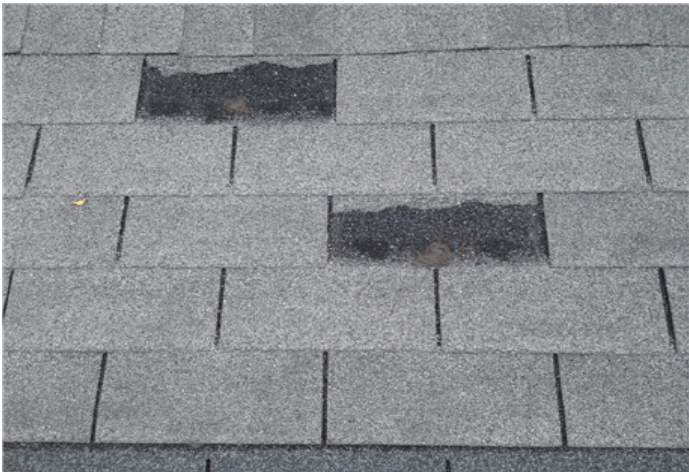
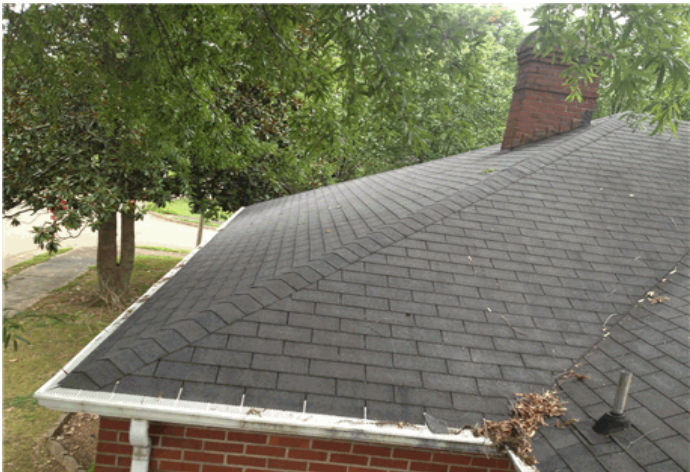
11) Roof Covering Condition

R

1. There where a few tabs missing. I recommend repair by a qualified contractor.

2. I recommend keeping limbs cut back off of roof, this is not good for shingles. See pictures.

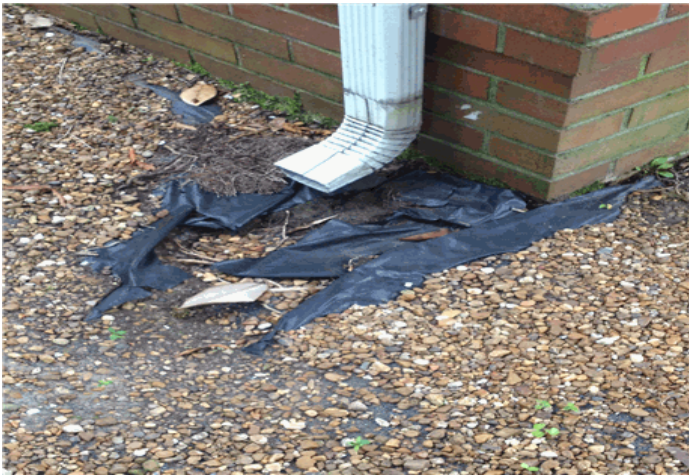
13) Gutter & Downspout Conditions

Downspout missing splash plate on front of home. The splash plate helps direct water away from foundation. These can be purchased at your local hardware store. See Picture

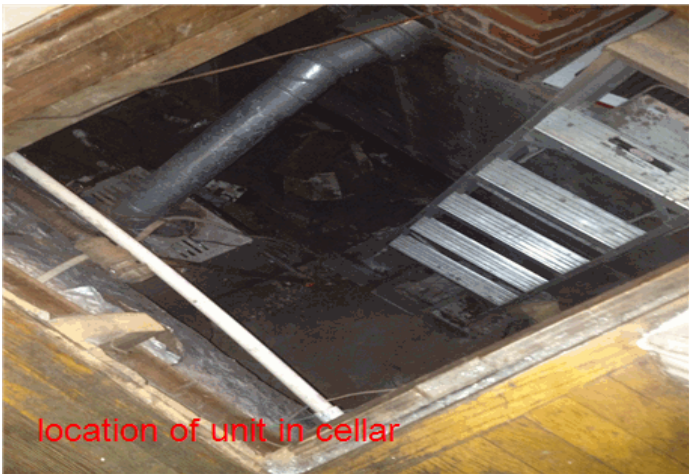
Location of Unit	Small Cellar area under home accessible through closet
Heating Type	Forced Air
Energy Source	Natural Gas
Approximate BTU Rating	36,000 (3 Ton)
18) Unit Conditions	<div>AS</div> Mfg. Feb. 2001 - 12 Seer

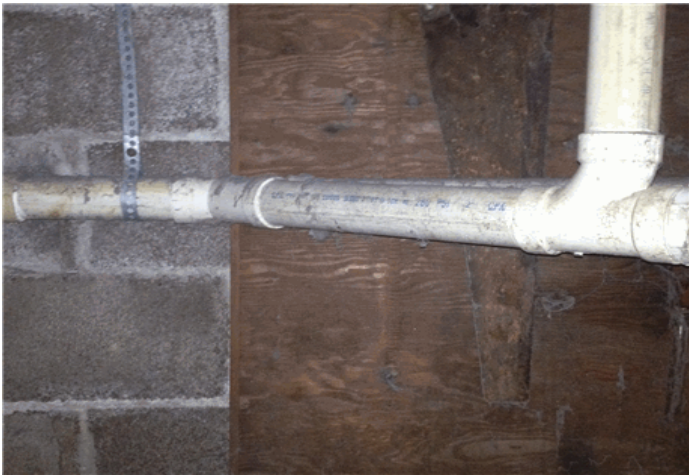
28) Drain Line Conditions

R Reverse slope causing Kitchen sink to not drain well. I recommend a qualified plumber for repair. See picture

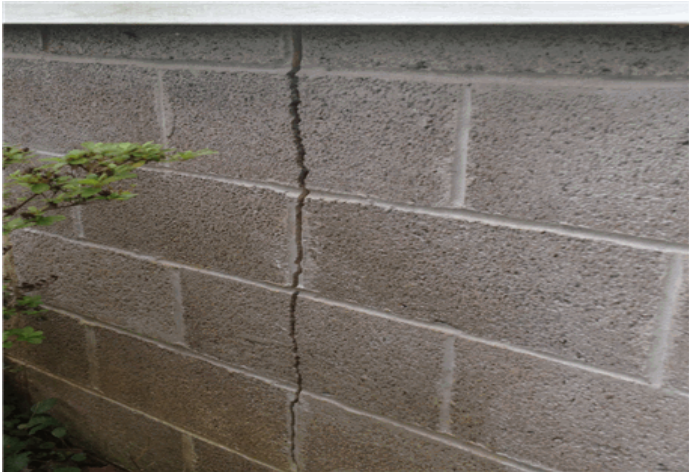
108) Foundation Conditions

R

Major crack, I recommend a qualified contractor for repair.
See picture

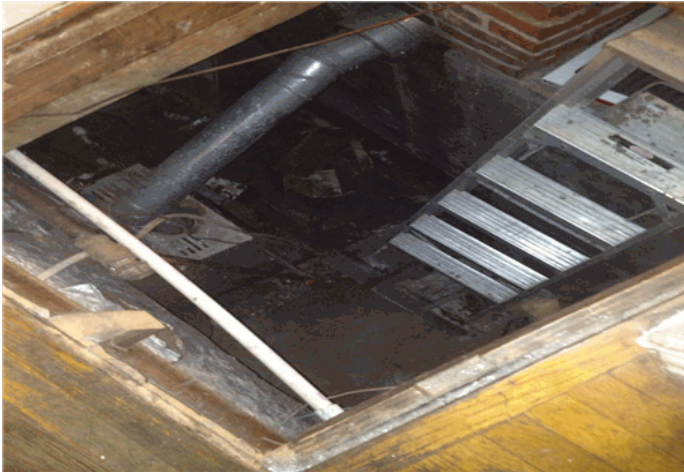
114) Trap Door Conditions

AS = Appears Serviceable**R** = Repair**S** = Safety**NI** = Not Inspected**NA** = Not Applicable**RM** = Routine Maintenance Needed**Trap Door in hall closet**

AS

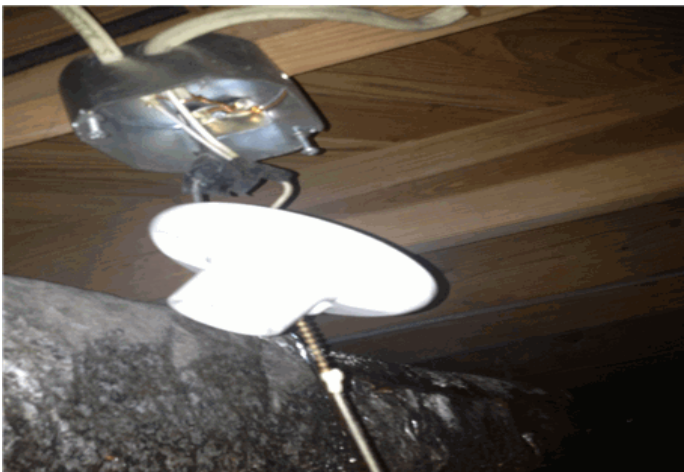
116) Lighting Conditions

R

In the small cellar area the light is not working and was hanging from wires.

I recommend repair by qualified electrician. See picture
